VEHICULAR CRASH TESTS OF
THE CALIFORNIA ST-20 BRIDGE RAIL
FINAL REPORT # FHWA/CA/SD/2004/01

**VEHICULAR CRASH TESTS OF
THE CALIFORNIA ST-20 BRIDGE RAIL**

FINAL REPORT # FHWA/CA/SD/2004/01

CALTRANS STUDY # 680323

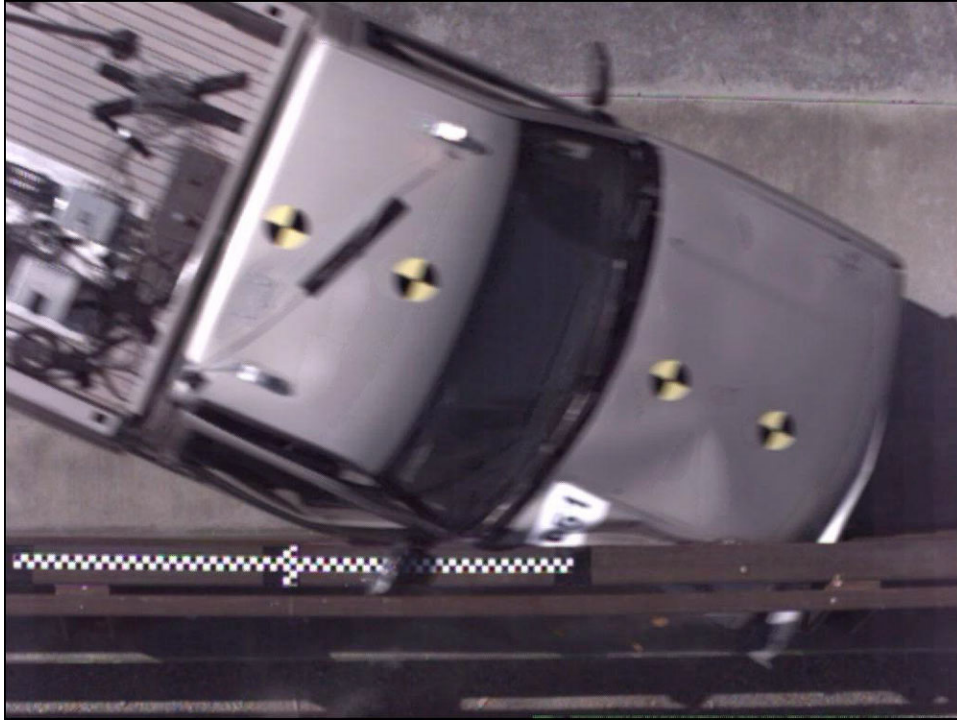
Figure 2-16 - Test 651 Maximum Hood Penetration, 64 ms After Impact

Maximum penetration of the hood occurred 64 ms after initial contact. From the overhead camera angle (see Figure 2-16), the hood penetrated 410 mm past the face of the barrier (or 320 mm past the face of the post). At 70 ms the hood contacted the third post. The leading edge of the hood started to pull away from the bridge rail as the back of the hood started to rotate back toward the windshield. A fold in the hood knocked the windshield wiper blade back, but did not penetrate the windshield. The hood lost contact with the third post 96 ms after impact.

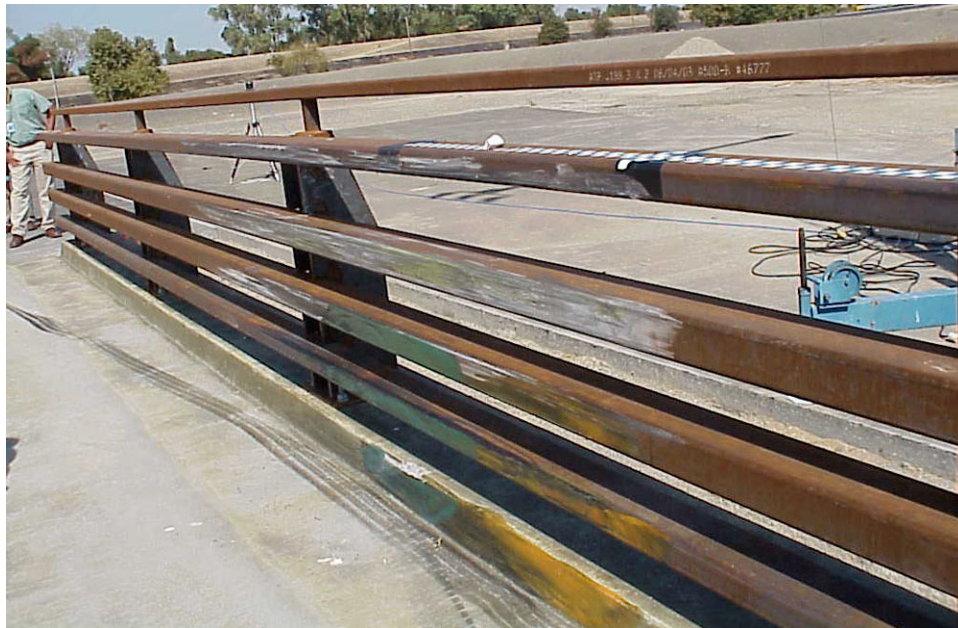
Figure 2-17 - Test 651 Rail Scuffing

Barrier damage was limited to minor spalling of the concrete curb and minor deflection of the rail. Rail deflections were measured mid-span between posts 2 and 3. The maximum dynamic deflection of the top rail of the ST-20 was 25 mm. The maximum permanent deflection of the barrier was 5 mm. Damage to the barrier was considered cosmetic and would not have required field repairs.

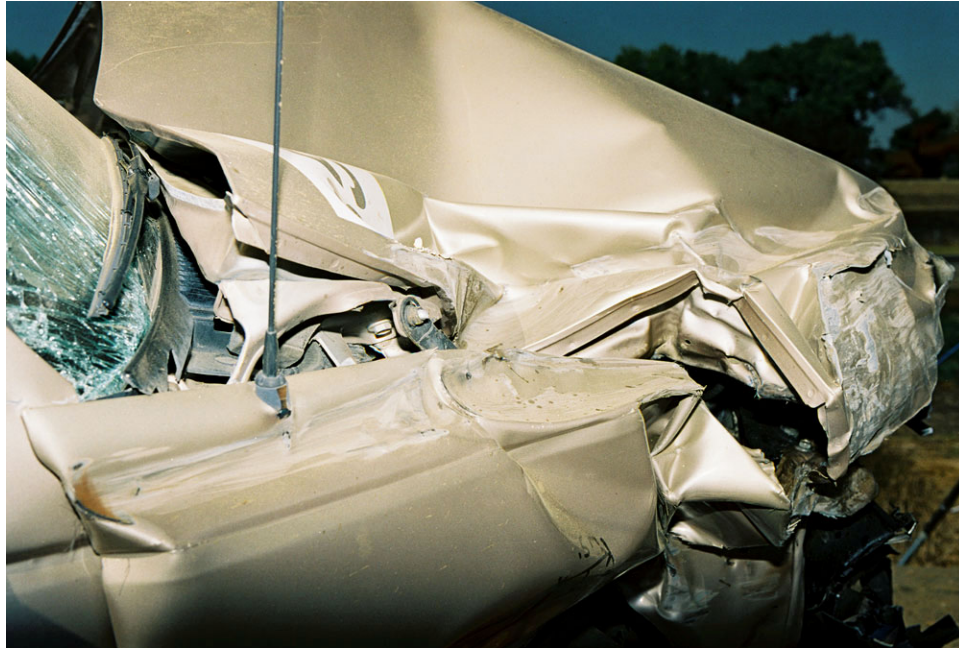
Figure 2-20 - Test 651 Vehicle Damage, Hood and Windshield

The windshield was severely cracked, but not penetrated (Figure 2-20). Cracks indicated that the windshield failed under flexure, instead of direct contact. The windshield wiper was pushed back and up.

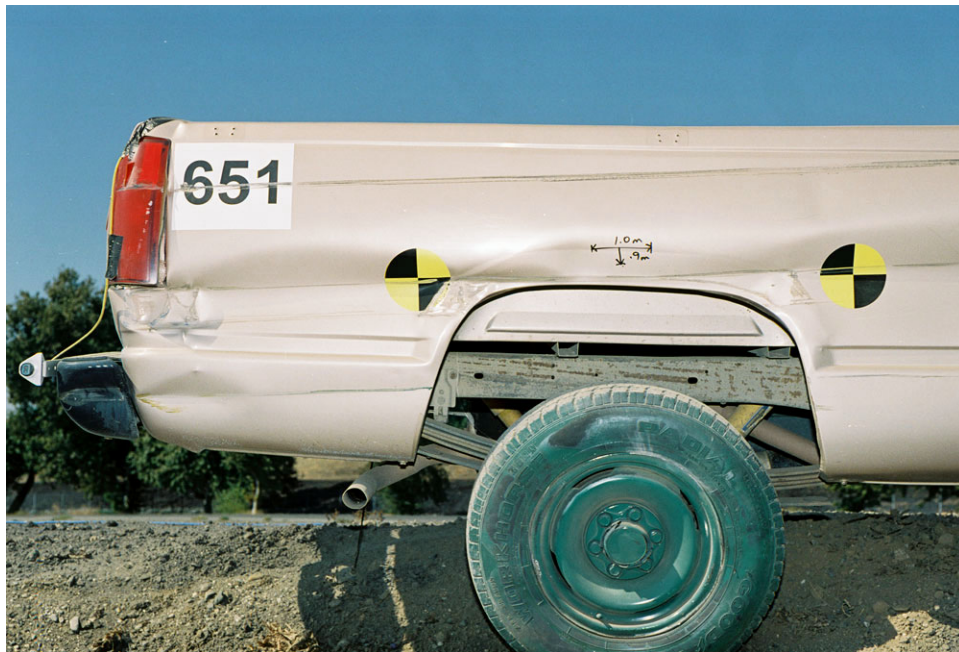
Figure 2-21 - Test 651 Vehicle Damage, Right Side of Truck Bed

The front right corner of the test vehicle sustained most of the damage. Additional damage also occurred to the windshield, the right side door, the side of the truck bed, and the floorboard of the passenger side of the cab.

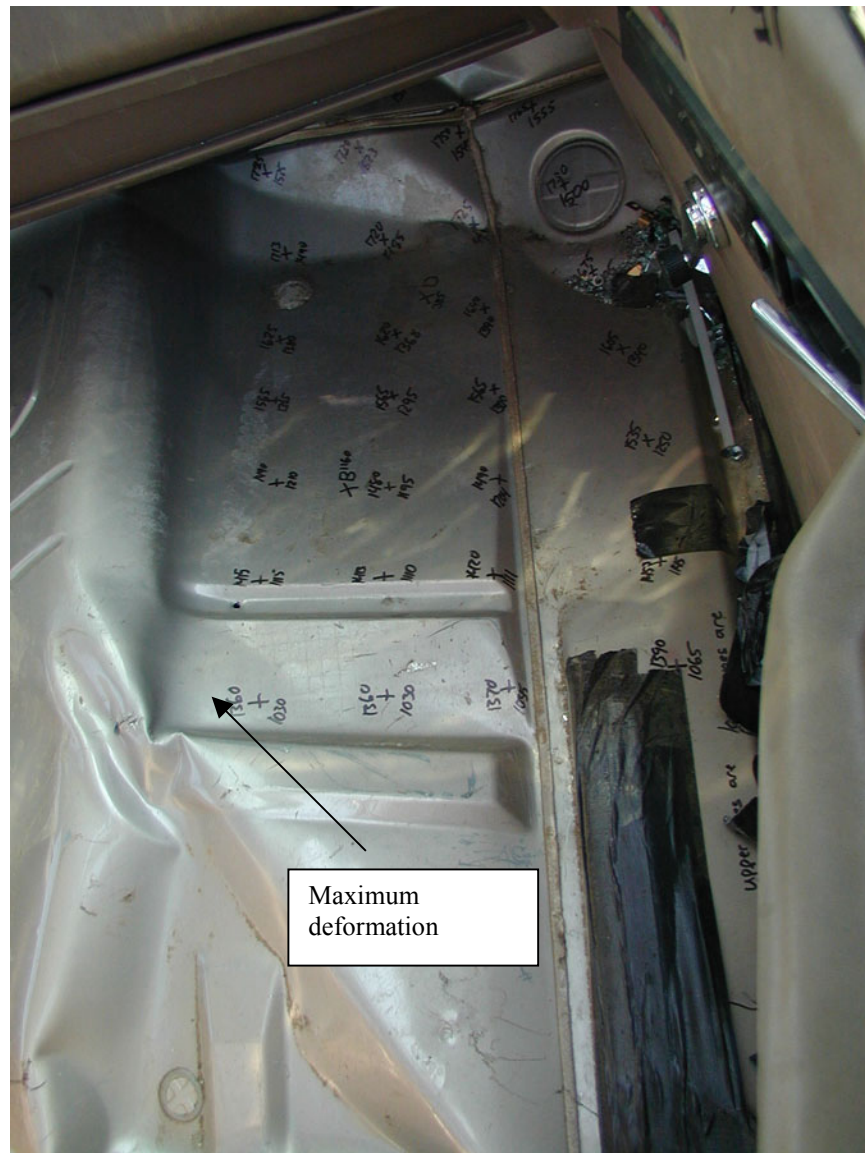
Figure 2-22 - Test 651 Vehicle Damage, Floor Deformation

The floorboard buckled due to the tire being pushed back in the wheel well (Figure 2-22). The maximum floorboard deformation was 25 mm and was located at the rise of the transmission hump midway between the front and rear of the cab.

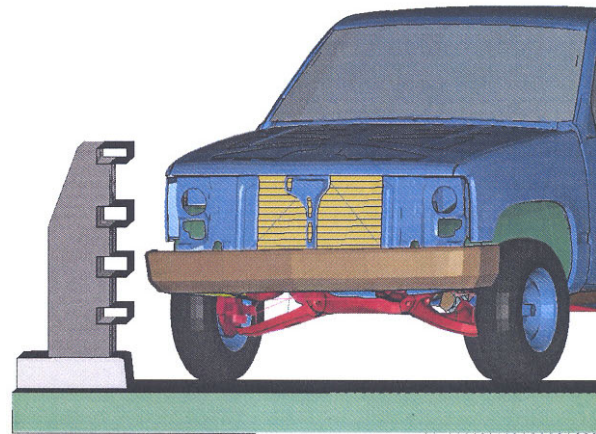
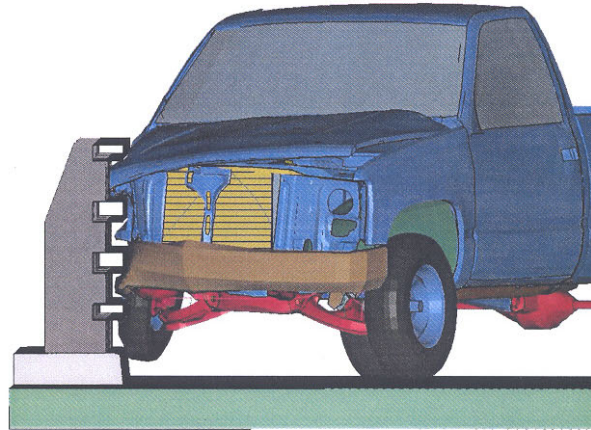
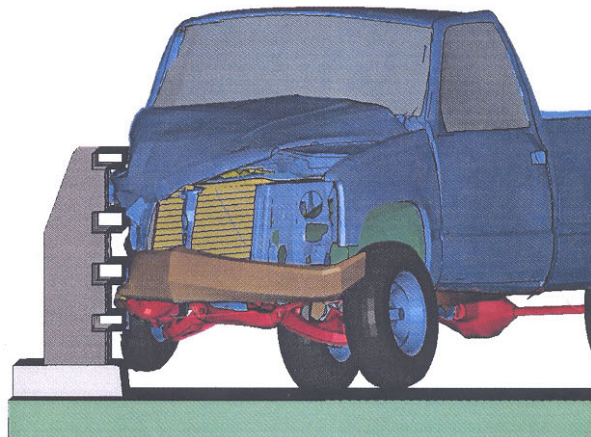
Figure 2. Front view of impact with the California ST-20 Bridge Rail.

Results from impact case (b) indicated a minor hood snag on the post that has a small effect on the cab deformations and collision response. The hood did impact the rail post, but the overlap was small and vehicle motions were sufficiently redirected so that large snagging forces did not develop.

Further assessment of the C2500 Detailed model is still needed as well as comparison with the Simplified Model. However, because the hood snagging occurs early in the crash sequence, and therefore model deficiencies may not be as significant as for longer-time behavior, we feel that these results indicate that hood snagging will be a problem for the current ST-20 configuration.
